Manhole Inspection Summary

Manhole # S43O__001MH

Insp Date: **5/19/09 11:56 AM**

Location Address: **1404 THAMES ST.**

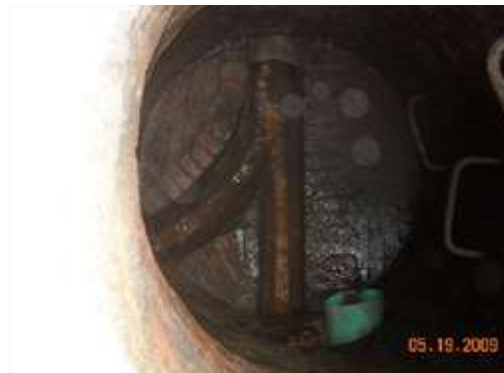
Top View

Frame Offset: **3** (in.) Condition: ☐ Sound ☐ Cracked ☒ **Leaks**

Condition: ☐ Sound ☒ **Cracked** ☐ Root Intrusion ☐ Loose Brick ☐ Deteriorated

Infiltration: ☐ None ☒ **Joint** ☐ Cracks ☐ Mortar ☐ Roots ☐ Wall

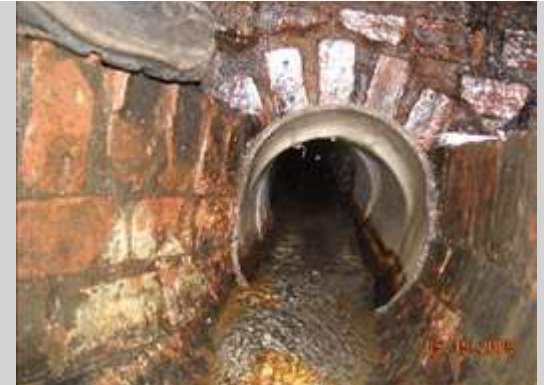
12 O'Clock Outflow

10 in. Circular Gravity Sewer
Pipe Out @ 12 O'Clock

Pipe Height: **10.8** (in.) Rod and Bar (Angled)
Pipe Material: **Clay** ☐ Pipe Lined
Invert Depth: **8.88** (ft.) Flow Characteristics: **Slow**
Deposits: ☒ None ☐ Mud ☐ Sludge ☐ Debris ☐ Grease
Silt Depth: **0** (in.) Deposits Extent:
Infiltration: **None** Pipe Seal Cond: **Sound**

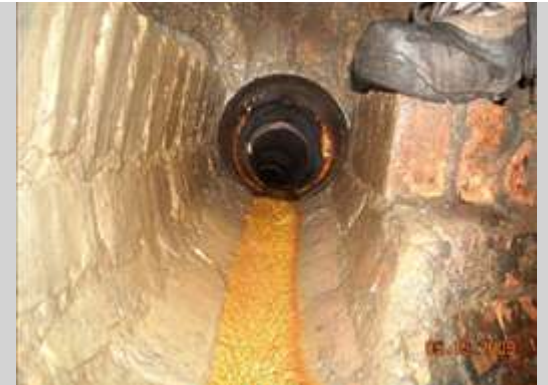
6 O'Clock Inflow

10 in. Circular Gravity Sewer
Pipe In @ 6 O'Clock

Infiltration: **Weeper**

Pipe Seal Cond: **Cracked**
